Ritron Model(s):	LM-700DMR and RIB-700DMR
Current Firmware Revision:	47.27
Revision Update:	Oct 02, 2025

LM-700DMR and RIB-700DMR Firmware Revision and Update History

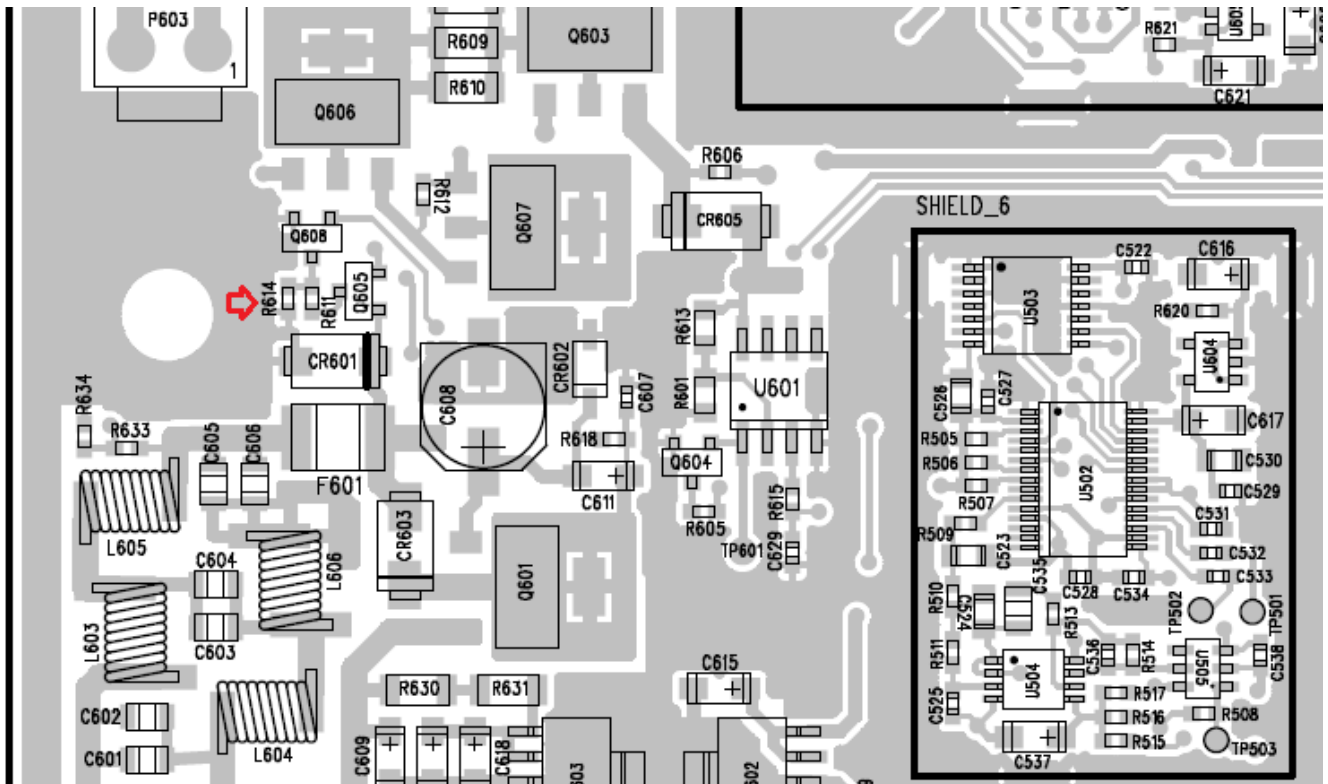
R614 vs. V22/V21

- 1) Added a feature that the unit can auto shutdown when 12V external power is lost and the battery is below 9.5V for at least 5 seconds. Before auto shutdown, the unit will beep 3 times. It is to prevent internal backup battery from over draining. To enable this feature, R614 (0 ohm) has to be removed. R614 was populated on the early units. With V22, if R614 is not removed, the unit will still work like V21, the battery dead auto shutdown just does not work. For the old version firmware, V21 and earlier, if R614 is depopulated, the battery backup function will stop working. i.e. depopulated R614 needs V22 or newer f/w to make the battery backup function work.

R614	Depopulated (new built)	Populated (old built)
F/W V22 and newer	Dead battery auto shutdown (lower than 9.5V) enabled	Dead battery auto shutdown (lower than 9.5V) is disabled, Same as V21 or older

F/W V21 and older

Battery backup function
will stop working

Dead battery auto shutdown
(lower than 9.5V) is disabled

Updated: Added above R614 part locator on Jul 8, 2025.
